Surface Water Problems in and around the village of Ducklington

Assessment and Action plan

April 2013

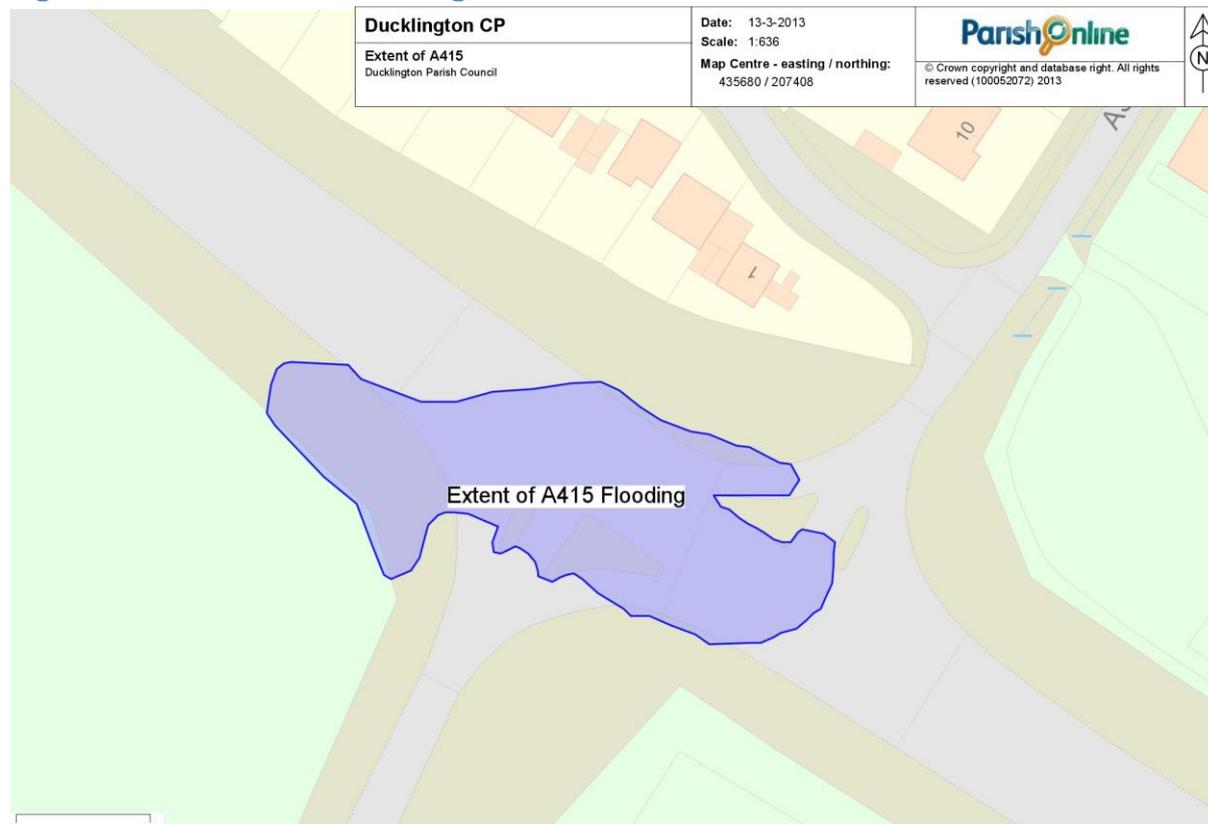
Figure 1 – Extent of A415 flooding

In this area the A415 is wide and flat. The water comes from the south side (i.e the north bound carriageway) and crosses the road heading to the lowest point at the junction with Aston road. The depth varies across the road from approx 10-20cm at Aston Road to 1cm in the middle of the A415.

The safety concerns are that with a long and wide road it is difficult to see the water which is present for over 30m of the length of the road at a shallow depth. This section of the A415 is subject to NSL (i.e. up to 60mph) and at these speeds aquaplaning and the resultant accident(s) becomes a real risk.

The depth of the surface water is sufficient at the exit slip from the A415 to Aston Road to prevent access to the village. At this depth it is not possible to see the submerged kerbs, verge and ditches. Vehicles attempting to enter the village do so via pulling into the middle of the A415 and entering via the exit slip. Given the water on the A415 this is considered dangerous by the Parish Council.

1. Create grip gullies to allow surface water from the A415 to flow into adjacent ditches. In particular at the junction with Aston Road (Witney side)
2. Clear and deepen the ditches on the Hardwick side of the junction with Aston Road
3. Inspect the diameter of the under road culvert and take appropriate action
4. Install a grip gully at the junction of A415 slip road to Aston

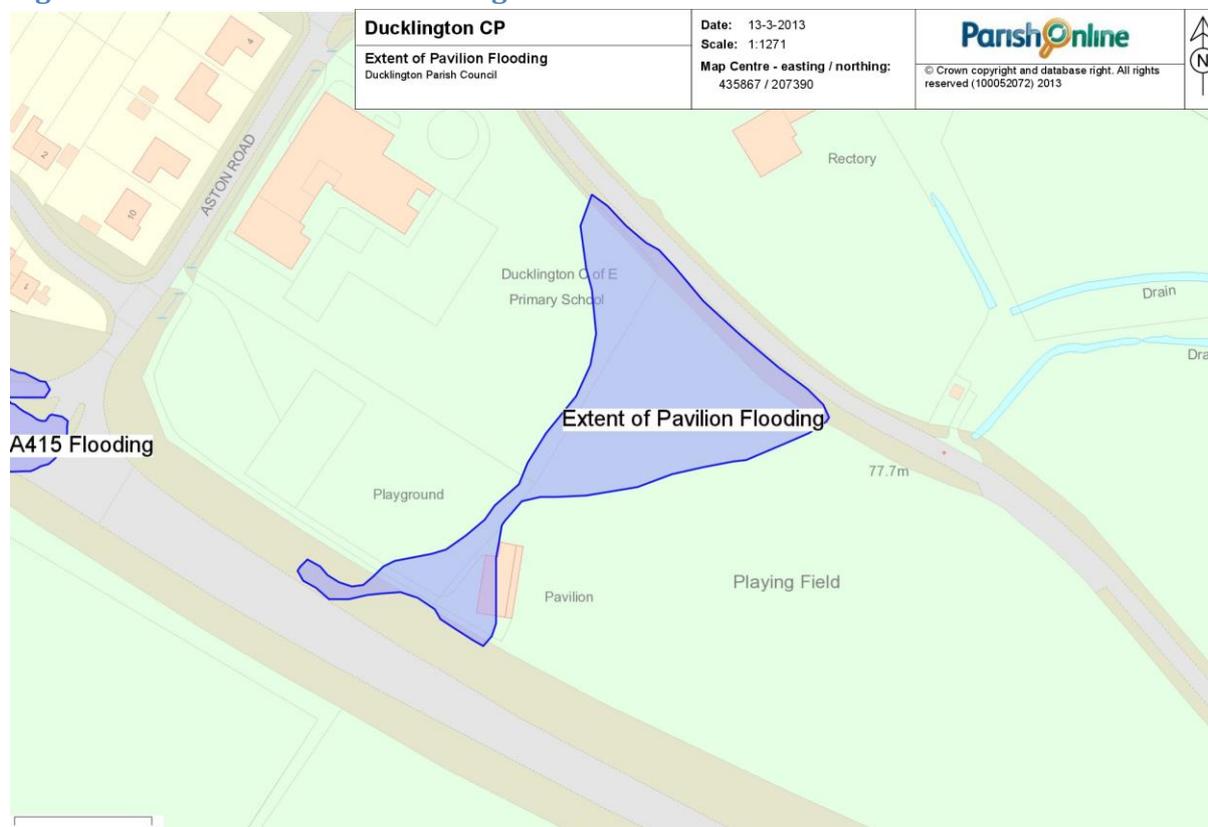
Figure 2 – Extent of Pavilion flooding

The surface water mentioned in the detailed assessment of area 1 flows down a ditch on the Witney bound carriageway crossing under the road before the Pavilion. There it crosses the highway verge and under another narrow access roadway before coming alongside the pavilion and the school. The ditch here is wide, however it narrows and shallows significantly at the boundary with the school.

The narrowing and shallowing causes the surface water to well up and spill out around the pavilion. In previous years this has caused significant damage to the pavilion and sports in the parish. The surface water also spills out into the sports field before re-joining the ditch at the gate to Standlake road closest to the Old Rectory. Further up stream this ditch splits and one leg passes up past the school along Standlake Road. This leg of the ditch spills out into the school playing field and front car-park.

The ditch from the pavilion to where it crosses under Standlake road was found to have a high level of littering and fly-tipping. Many tyres, loam bags and drinks bottles were found to be obstructing the water flow in many locations along the length of the ditch.

Also at this location after any heavy rain the virtual footpath at the junction of Standlake Road with the Village Hall access road floods putting pedestrian, often accompanied by young children, at risk of injury by collision with vehicles at this bend.

1. Empty the ditches of fly-tipping and littering on a regular basis
2. Deepen the ditch from the pavilion through to the junction with Standlake Road
3. Inspect the path of the ditch from Standlake Road through to the river

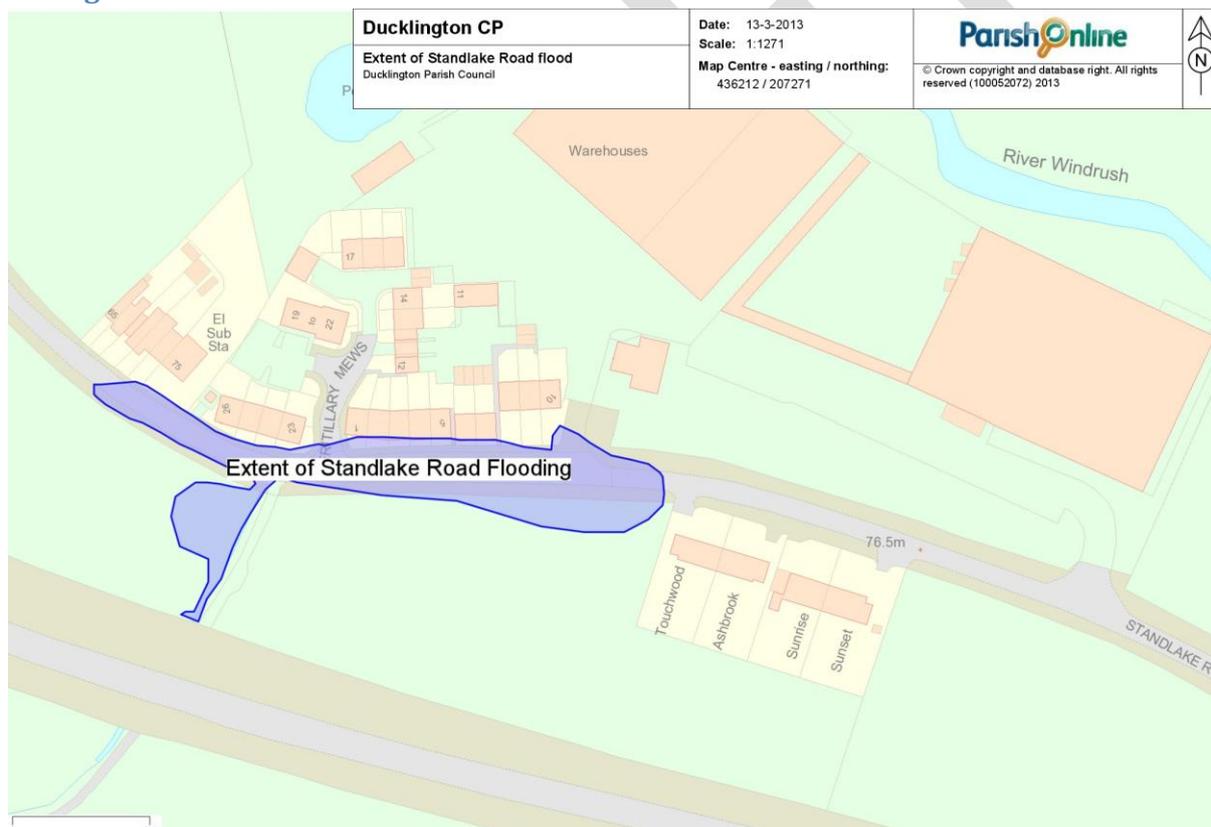
Figure 3 - The ditch from the A415 along Standlake Road past Fritillary Mews and through to the river

The surface water at issue here also comes from ditches draining the A415 and land around. Here the water comes through a ditch in the highways verge and runs along the bottom of the sports field. This section has recently been cleared of vegetation. It abuts Standlake Road and where it is joined by a short length of ditch that starts with a headwall from the outflow of a road gully adjacent to number 75 Standlake Road. The ditch at the headwall was silted up so as to obscure a view of the pipe. During significant rainfall water passes back up this gully and spills out into Standlake Road putting the immediate properties at risk.

The ditch travels along Standlake Road in front of Fritillary Mews (numbers 1 to 10). There is an earth bund and there are non return valves on the roadside gullies. However, there are some pipes through the bund with no non-return valves rendering the bund useless. The construction of the gullies is of poor quality, particularly the kerb surround that protects the bund. It was also noted that the bund was not high enough in the middle opposite number 5 Fritillary Mews.

The ditch then meets a headwall as it passes underneath Standlake road. This under road culvert was noted to be a significantly smaller diameter than those upstream. During significant rainfall the

level of water in front of this culvert rises significantly and causes the non-return valves to close. This in turn forces the water out of the gully in front of number 75 Standlake Road. This combines with normal surface run-off and causes a pool of surface water to pool on Standlake Road on the other side of the protective bund.

The flooding in Standlake Road is often sufficiently serious as to render it impassable and put the properties adjacent at risk.

It was also noted that at this end of the village the foul water drains are very shallow and have to be pumped at a Thames Water pumping station just up from the affected area. The old foul water drainage runs alongside the surface water drainage ditch and some of the manhole and inspection covers needed attention to prevent cross contamination.

1. Dig the ditch at the headwall to the gully on Standlake Road
2. Fit a non-return valve to this gully headwall
3. Clear the ditch from the culvert under the A415 through to the culvert under Standlake Road
4. Build up the protective bund opposite number 5 Fritillary Mews
5. Significantly enhance the diameter of the culvert under Standlake Road
6. Repair the roadside gullies opposite Fritillary Mews
7. Stop-up the pipes through the bund
